## Isofix retrofit at the backseat

**Volvo V70 P26, XC70 (2001-2007), XC90 (-2014), S80 (-2006), S60 (-2009)**

The Isofix retrofit on the rear seat bench is completed in just a few steps.

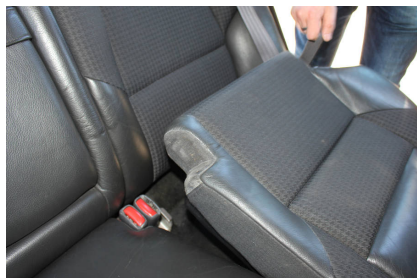
Fold up the seat cushion.

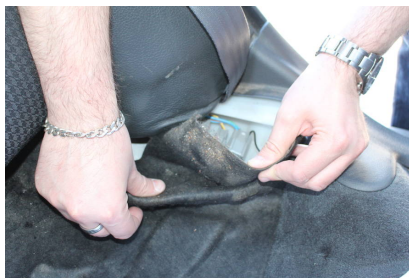
Pull the insulation mat out from under the sill cover and fold it aside.

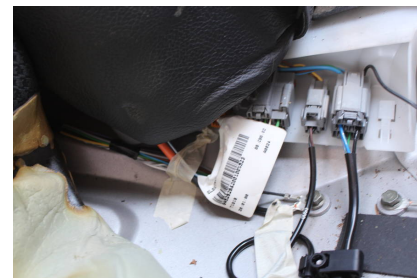
There are cables harnesses below the insulation mat. Tape them to the floor to prevent contact with the Isofix-Bracket.

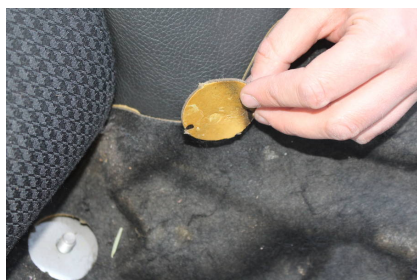
There is a pre-punched hole inside the insulation mat which covers a stud.

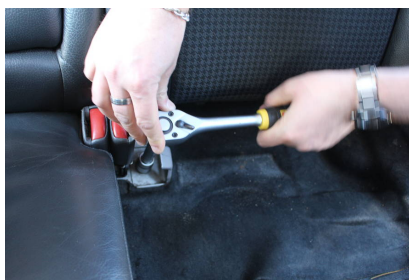
Undo the belt lock mounting screw.

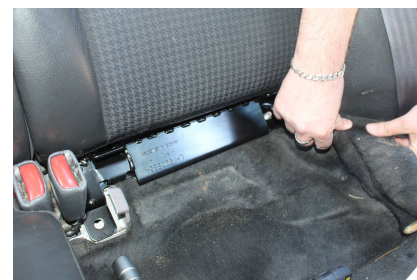
Place the Isofix bracket.

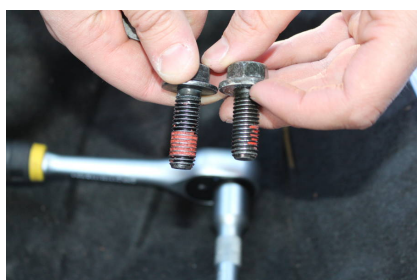
The kit includes a new longer screw. Mount the Isofix bracket and the belt lock together with the new screw.

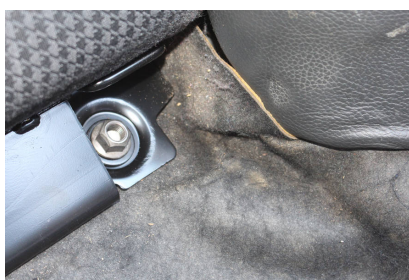
On the other side the Isofix bracket is mounted to the stud using the new supplied nut. Because the nut is self-locking crimped, tightening is relatively difficult.

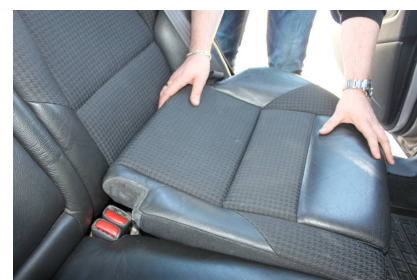
Fold down the seat cushion.

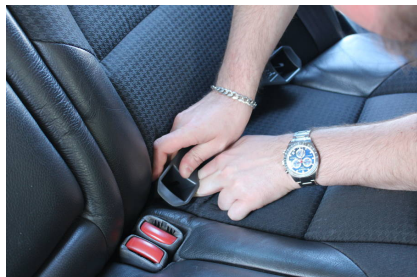
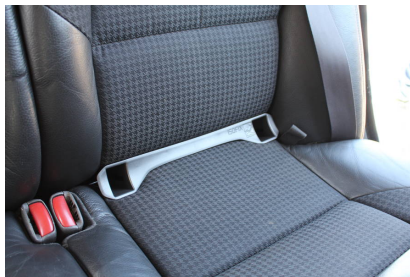
We recommend to use a cover which is simply pressed on the ISOFIX brackets and spreads the upholstery to make the brackets reachable. They also prevent the upholstery from being damaged when the child seat engages.

This is the 1-parted version, Skandix 1028109.

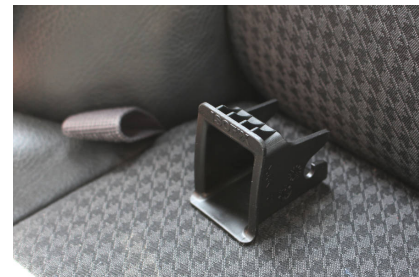
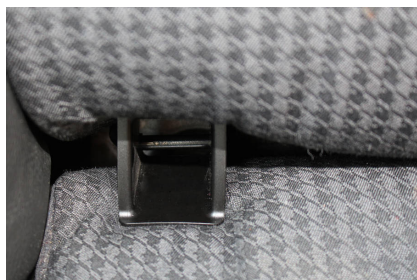
We recommend to use a cover which is simply pressed on the ISOFIX brackets and spreads the upholstery to make the brackets reachable. They also prevent the upholstery from being damaged when the child seat engages.

This is the 2-parted version, Skandix 1048318.

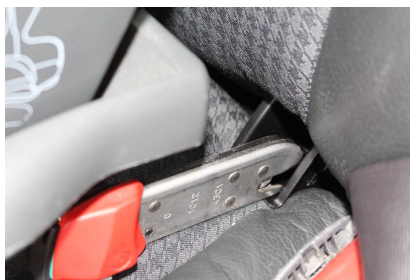
Fit the children seat according to the manufacturer's instructions.
